**Pine Forge Iron Plantation:  
History, Building Chronology, and Recommendations for Preservation**

Melissa Pilar LaValley

A THESIS

Historic Preservation

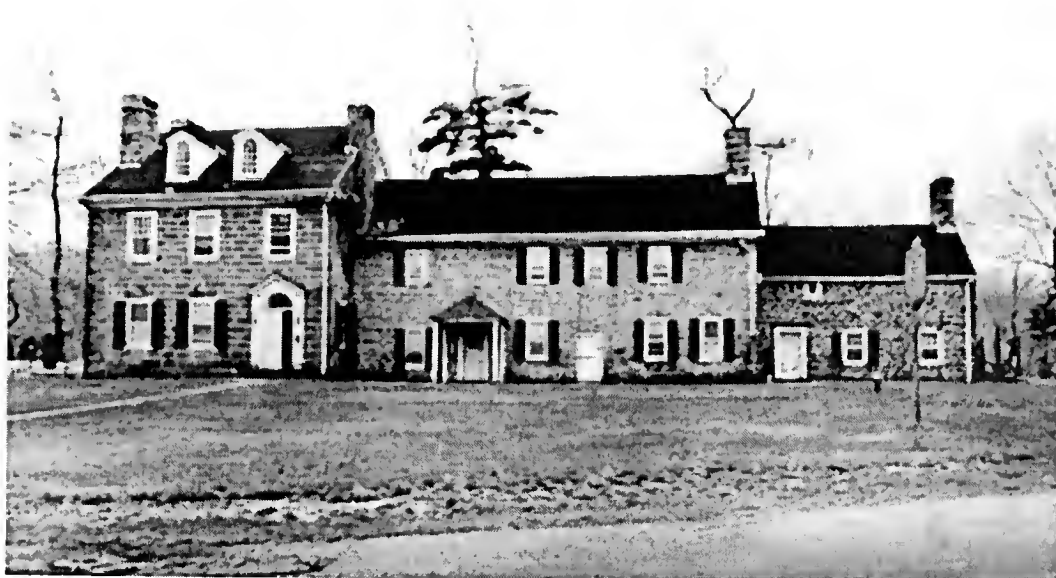
The principal façade faced east, away from the activity and smoke of the forge, and was distinguished from the other facades by having masonry laid in an irregular ashlar

**Figure 5 East Façade of the Main House, looking west, 2001**

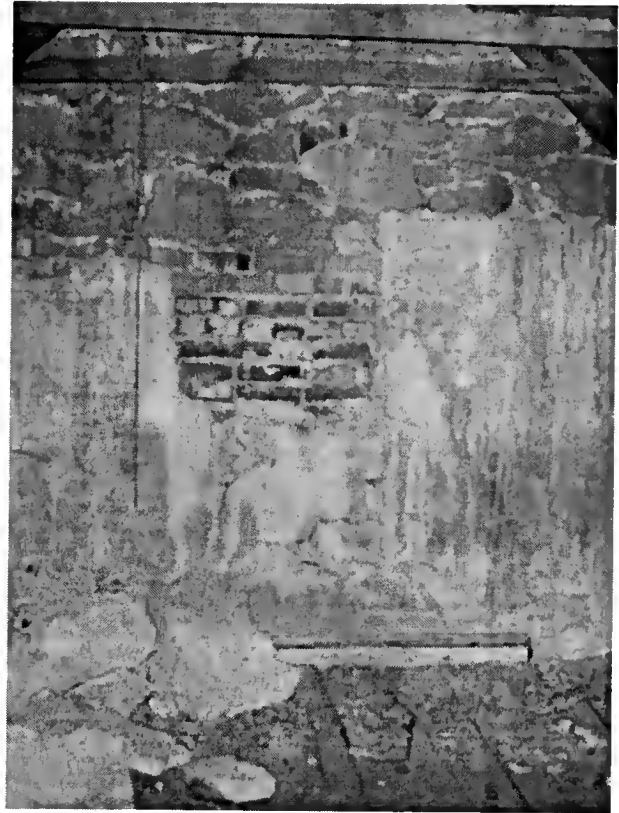
The other three façades were laid in a coursed rubble pattern. Figure 6 shows the bricked in, rectangular opening, in the south gable-end of the attic that provides the only definitive evidence of openings on the south façade. The north façade was substantially rebuilt during the construction of the north wing, so

**Figure 6 South Gable-End in the Attic of the Center Section of the house, 2002**

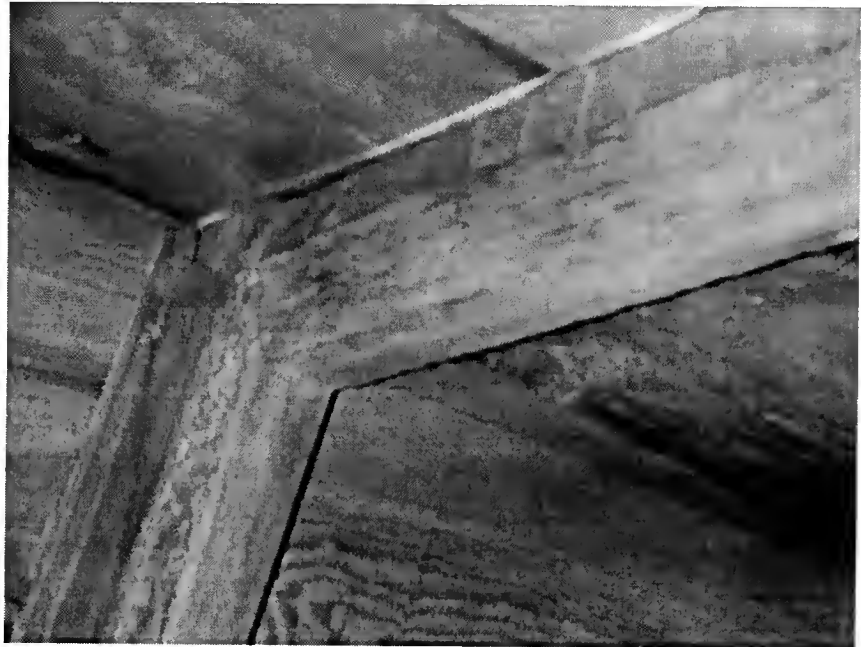
mortice and tenon carpenter's joints and wooden pegs, this type of roofing system is still in place in the center section of the house as

**Figure 8** Original Rafter in Center Section of Main House, 2002

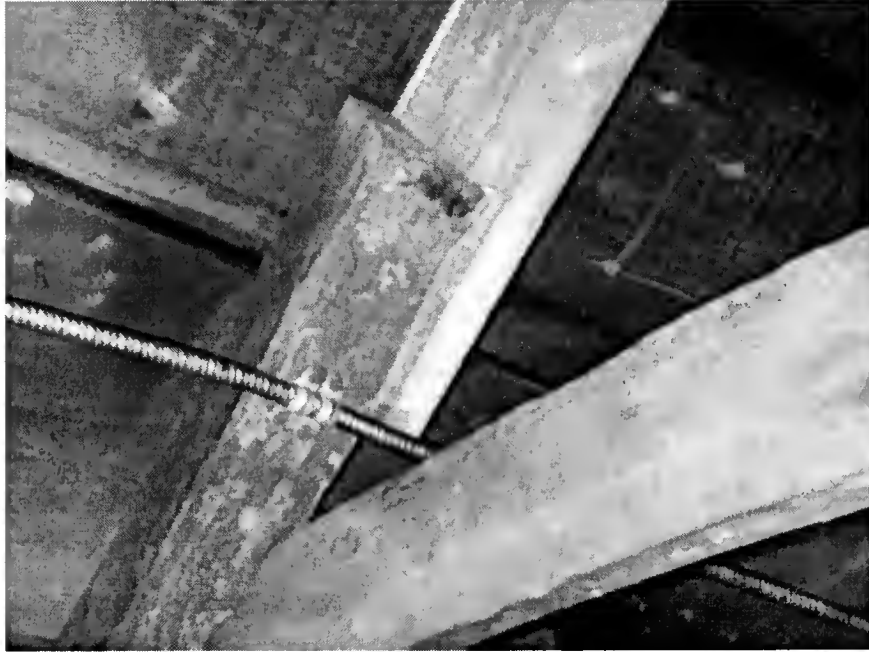
**Figure 9** Cut-off Rafter in Center Section of the Main House

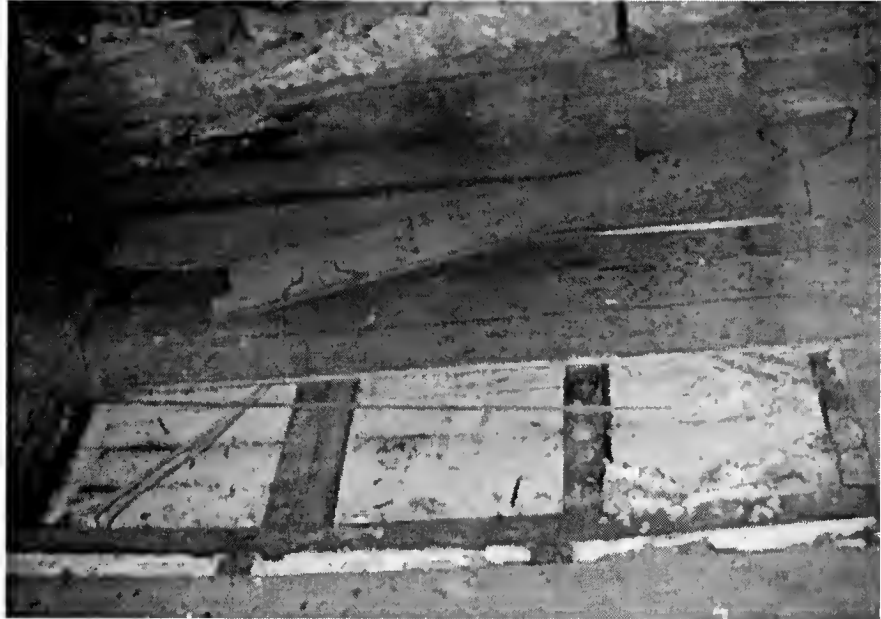
**Figure 10** Opening for original Winder Stair, 2002

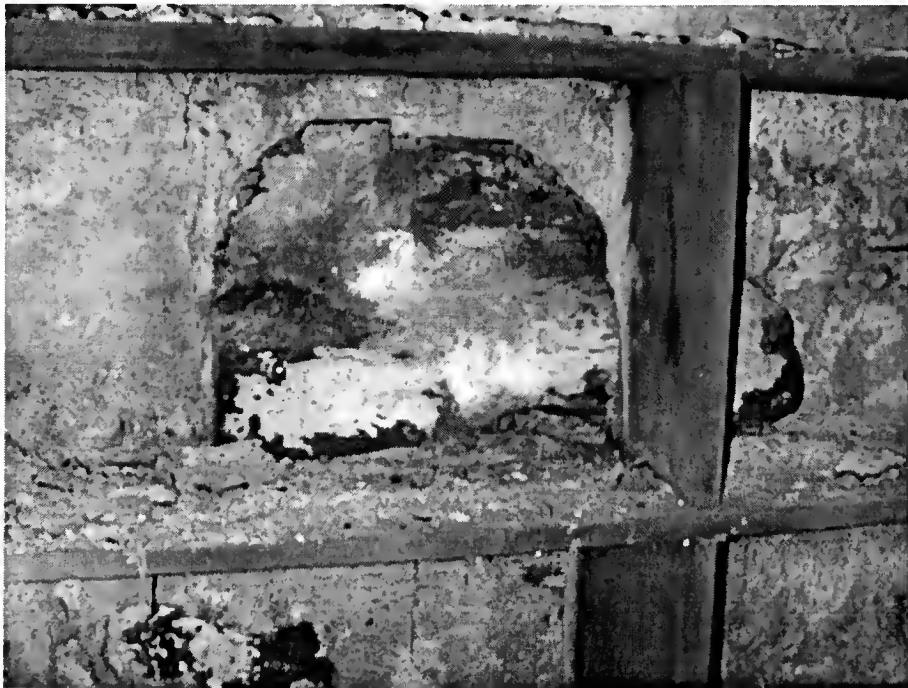
Figure 11 depicts a large chunk of stone jutting out of the south side of this wall several feet above the basement floor. This may be a portion of the corbelled support for the fireplace associated with the center chimney. In the southeast corner of the basement

**Figure 11 Stone Jutting from the Interior Masonry Wall in the Basement of the Center Section of the Main House, 2002**

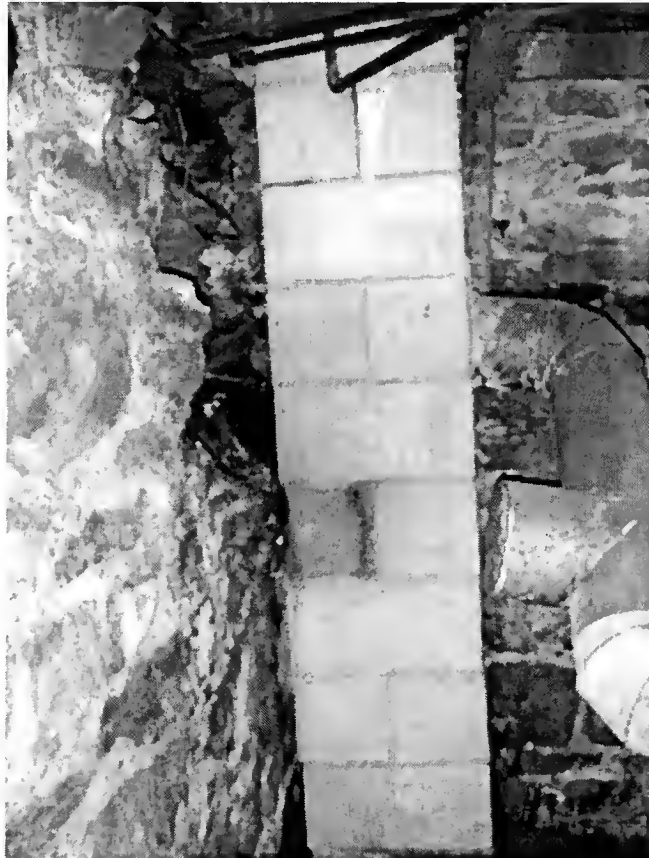
there is a large double header outlining a triangular opening in the first floor flooring and joists. While this header does not date to the original construction it does corroborate other evidence for a corner fireplace in the attic. Besides this header, pieces of the

**Figure 12** New Chimney and Disturbed Stonework in southeast corner of Basement, 2002

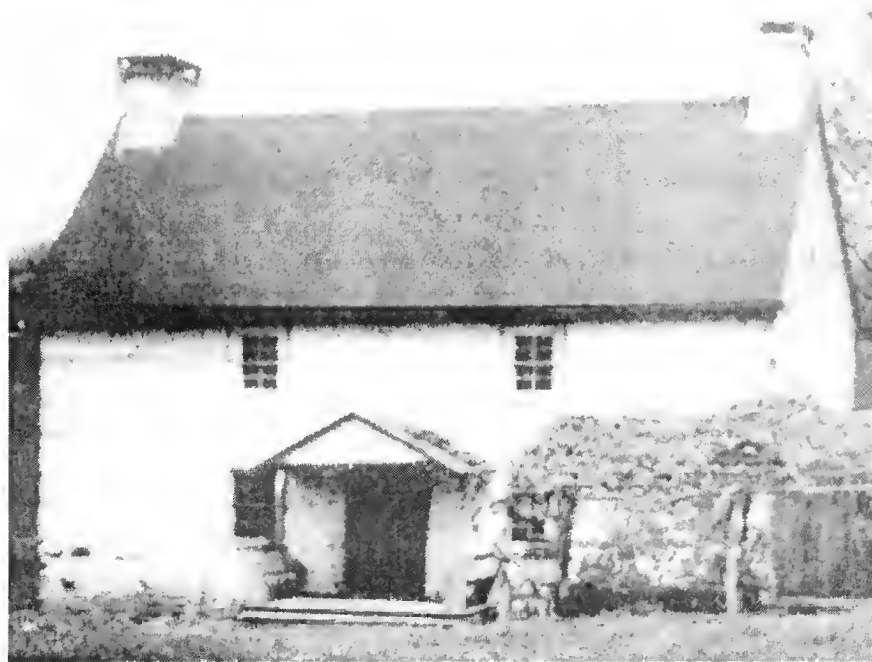
**Figure 13** George Boone House, photograph c. 1930

compared to the Boone House, shown in Figure 13, the center section of the Rutter House appears considerably larger, especially in its length. Philip Pendleton explains this by noting that the

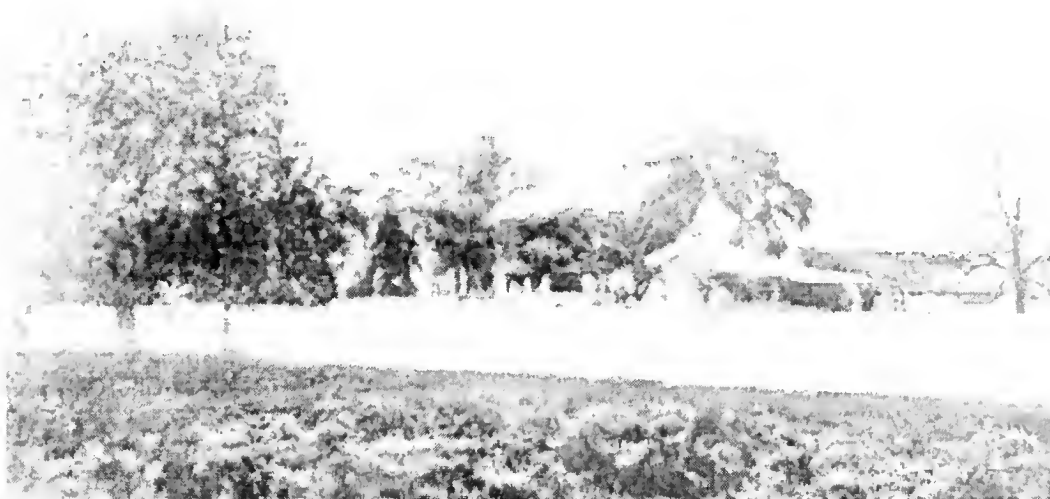
**Figure 18** Manor House, looking southwest, 1872

The description of the dwelling house matches that found in previous sale notices and indicates that this advertisement was published prior to the addition of the south wing. This advertisement, though undated, along with the financial difficulties mentioned above, provides evidence that south wing was not built prior to 1798. In addition, the inclusion of a “counting house” in the same phrase as the dwelling house may identify the small, hipped roof appendage on the north side of the center block in the 1872 photograph (Figure 18).

The interior chimney mass in the center section of the house had been removed by the time of the 1872 photograph (shown in Figure 18). Although the exact date of its removal is unknown, it seems likely that it was removed during David Rutter's

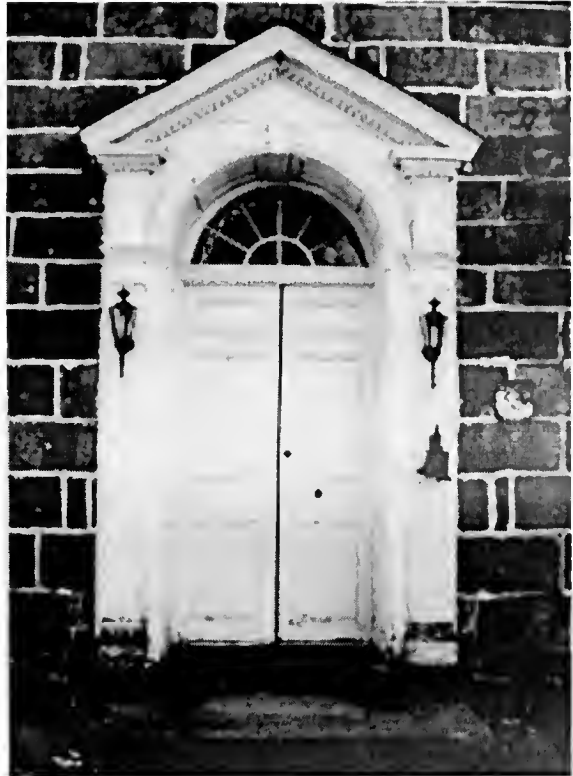
radiating muntins and lead-came spiral ornament and the entry reveals are raised panel jambs that match those of the paneled doors. The pedimented dormers mimicked the decorative details of the main entrance, with reeded pilasters supporting the pediment and an arched window surround with a quirk molding containing a key block at the top of the arch. Arched, eleven over six double-hung wood sash windows with fan-shaped lights at the head of

**Figure 19** Front Entrance of the South Wing of the Main House, 2001

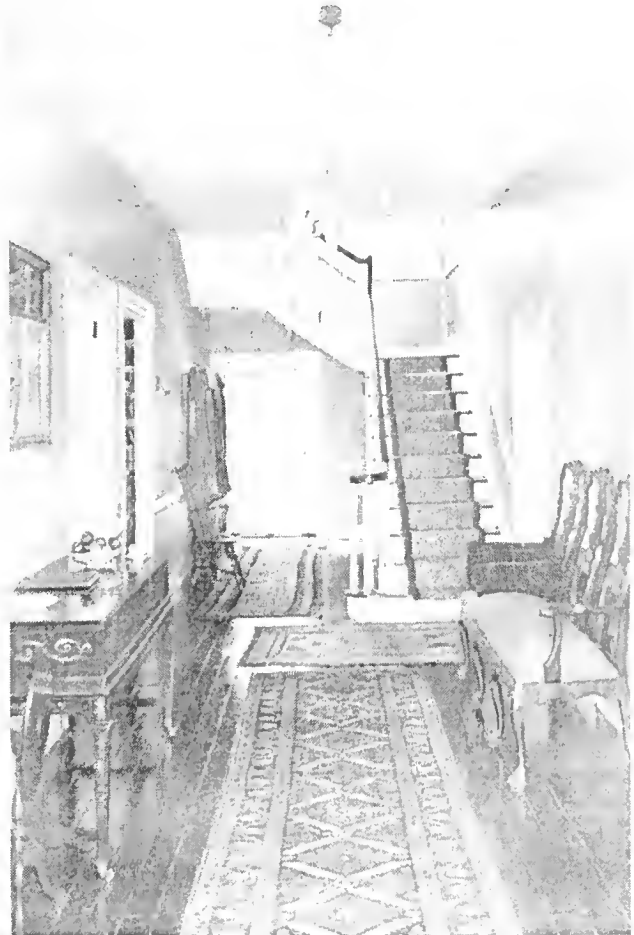
Unlike the center block, the original interior layout of the south wing appears to be substantially intact. As it did originally, the first floor consists of a stair hall and two rooms. The stair hall extends the full depth of the house with a dogleg stair at the west end.<sup>71</sup> The staircase, which runs from the first to the third floor, retains its original configuration and decorative details. Figure 21 shows the stair; it has turned balusters and an arched rail cap, with a molded chair rail that continues along the stairwell wall as a reflected handrail and closed stringer stairs decorated with scroll brackets at each step. At the east end of the hall, the original front door is framed

**Figure 21** Stair-hall in the South Wing of the Main House, c. 1938

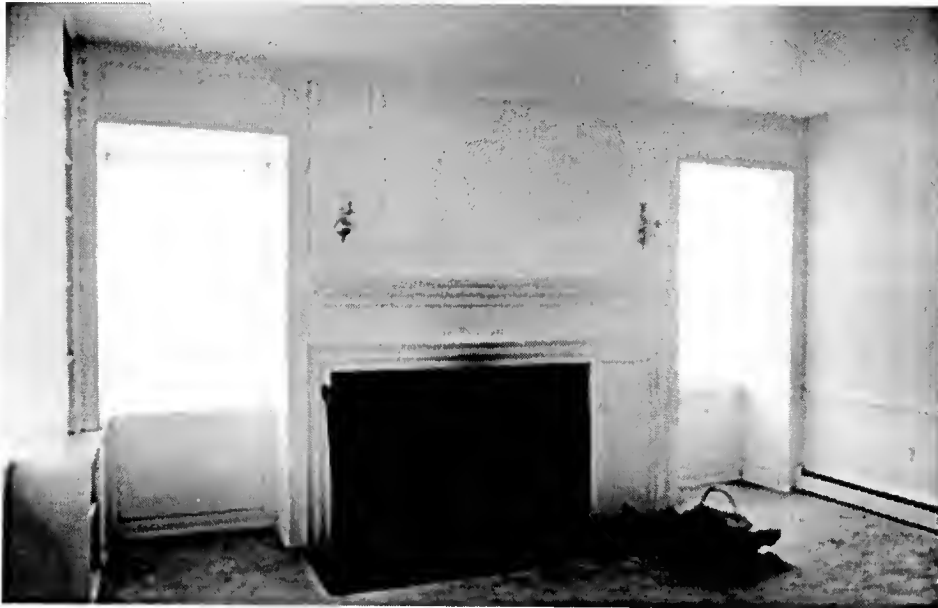
**Figure 22 First Floor East Room, South Wing of the Main House, 2001**

currently hung in this doorway is not original. These rooms also retain the original chair rail. Figure 22 shows the fireplace and two windows on the south wall of the east room. While there was a fireplace and one window along this wall originally, the current features appear to be replacements, probably done during Okie's c. 1918 work.

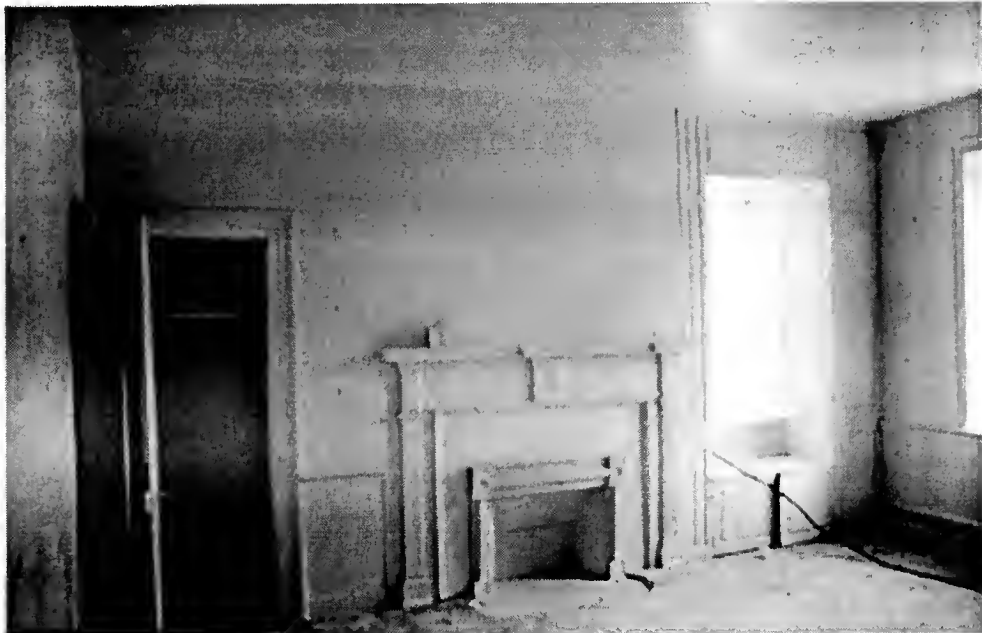
**Figure 23** Second Floor West Room, South Wing of the Main House, 2001

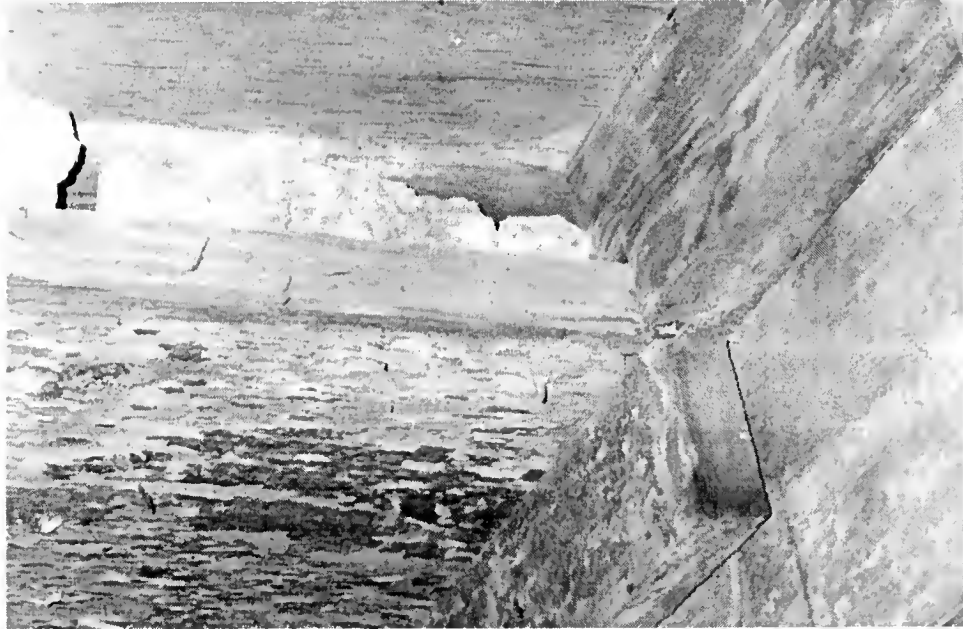
**Figure 25** Close-up of “Palling” under the floorboards in the Basement of the South Wing of the Main House, 2002

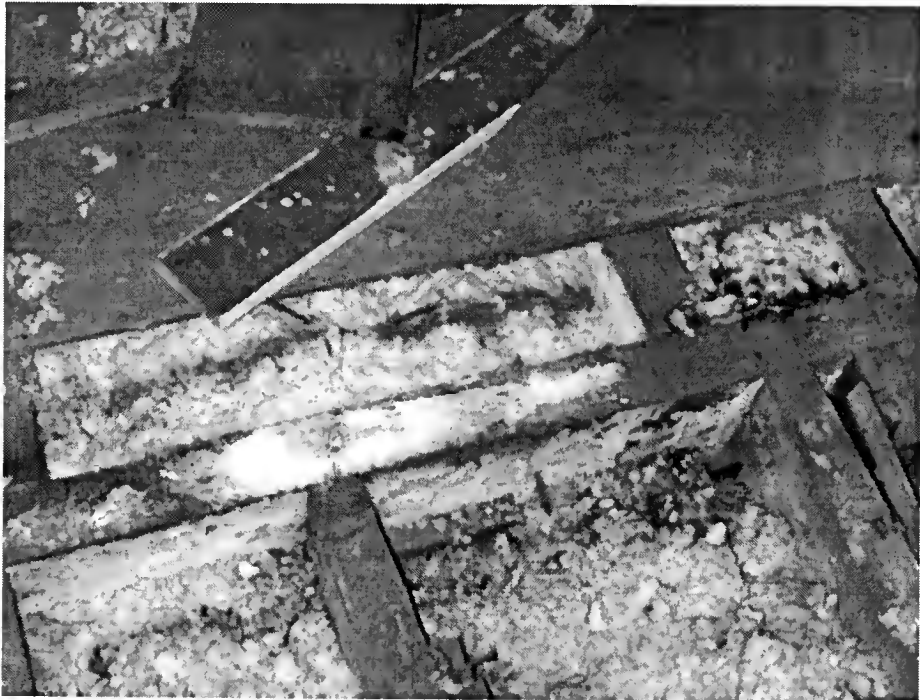
**Figure 26 Header for second generation Stair in Attic of the Center Section of the Main House, 2002**

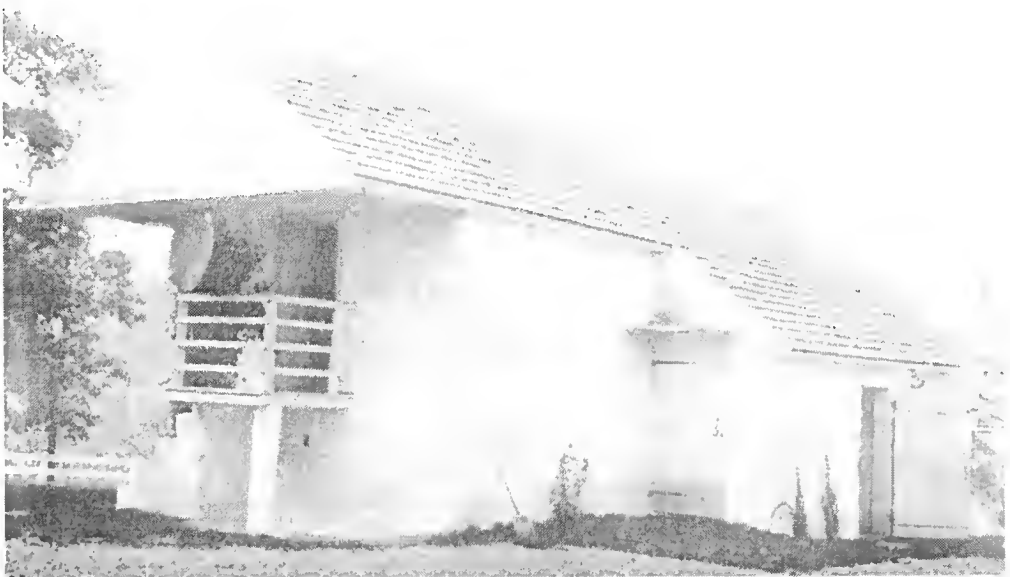
**Figure 27** Smokehouse/Root Cellar, looking southwest, c. 1931

The long, low, rubble stone smokehouse/root cellar building, shown in an undated photograph in Figure 27, has a front gable, wood shingle roof and is comprised of three

There is little information regarding the other buildings during William McMurtrie Rutter's ownership. The appearance of the smokehouse/root cellar building is represented in a photograph published in 1931 (shown in Figure 27). The appearance of the building in this photograph relates to the Okie aesthetic of the main house but there is no additional evidence to prove

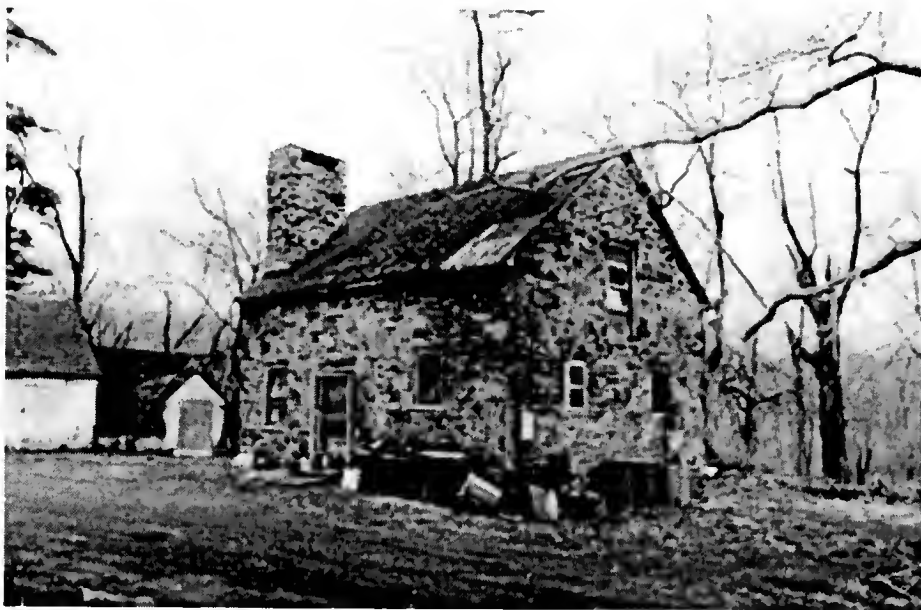
**Figure 28** Caretaker’s Cottage, looking southwest, 2001

Currently known as the “caretaker’s cottage,” the construction date and use for the 1 1/2 story, rubble stone building is unknown at this time. An 1802 tax list records a “counting house” as part of the taxable property of David Rutter and a list from 1805 records an “office.” Another account, states that there was a “counting house” or “office” with barred windows<sup>76</sup> located near the main house. As shown in the current photograph in Figure 28, this building has several barred windows. The building also has a plain, closed wood eave and a side gabled roof that was probably covered with hand split wood shingles like the main house. An interior chimney protrudes just below the roof ridge at the southeast corner of the building.

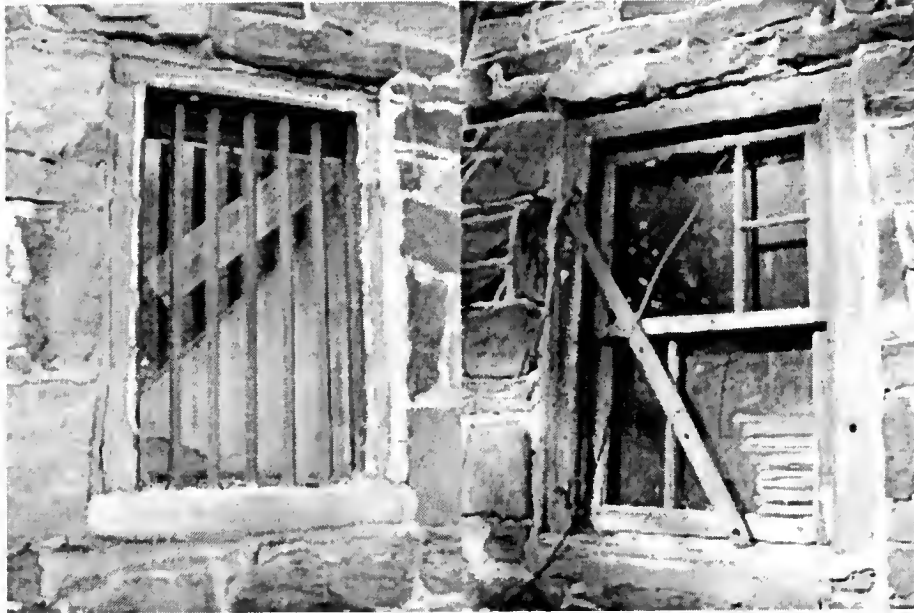
**Figure 29 Window Types on Caretaker's Cottage, 2002**

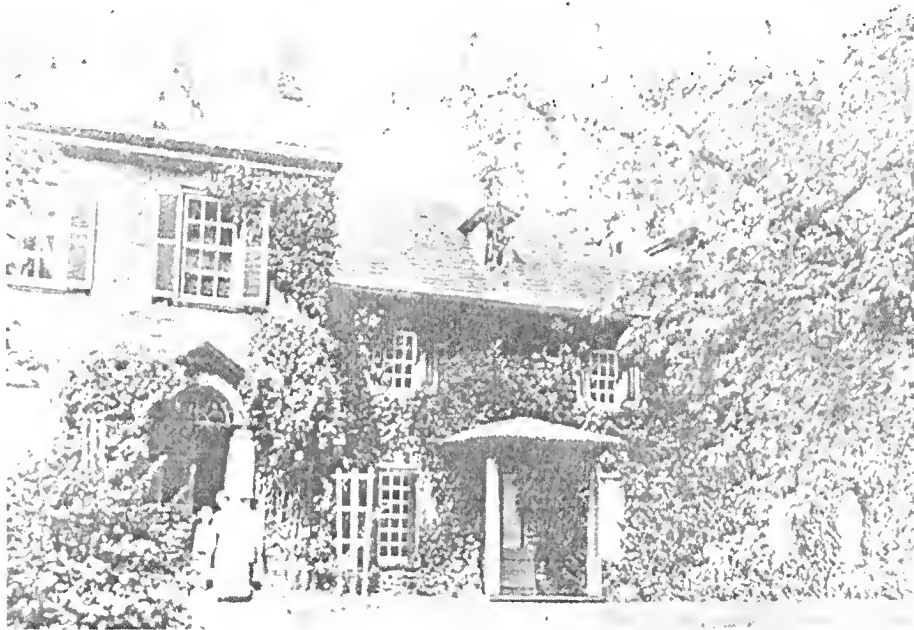
**Figure 31** Manor House, looking west, c. 1914

shown in Figure 31, shows a large first floor window that interrupts the water table, the hipped roof porch, and two dormers on the east roof slope of the center section of the house.

the top sash are hung in the dormers. This window sash may or may not be original. The other windows on this wing match the shape and size of the original masonry openings but as the c. 1914 photograph shows in Figure 31, six-over-six window sash predate the twelve-over-twelve sash currently in place. The size of these window openings indicates that the six-over-six sash, which was in keeping with the fashion of the time, was the original sash configuration.

There is also an etched stone bearing the legend, “1858/JLB/PF,” laid in the stonework around the current doorway. This may provide a date for some of the renovations made to the house by Joseph Bailey. The photograph in Figure 31 provides the best evidence for the appearance of the house after these renovations. Note the hipped roof porch and the large first floor window that interrupts the water table. It appears that the Bailey’s retained the dormers on the center section of the house.

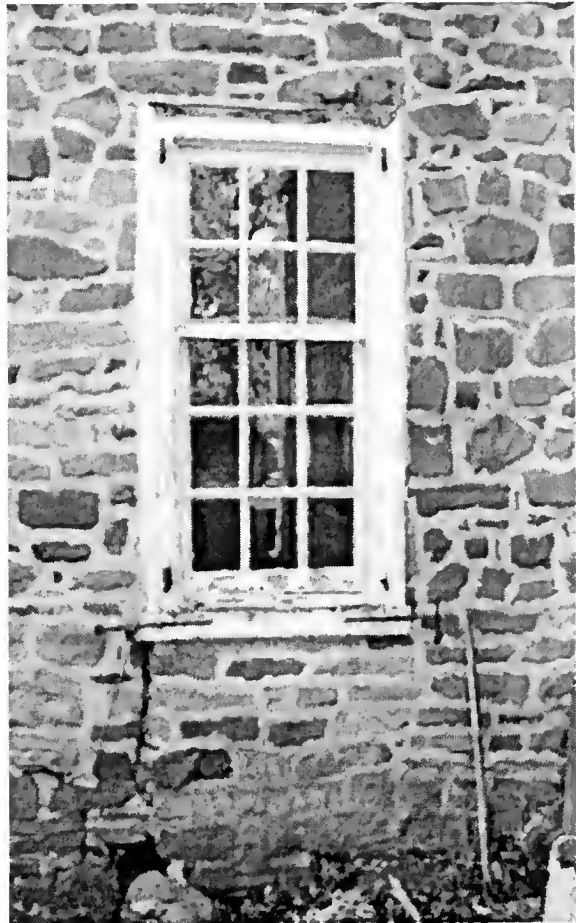
**Figure 32** North Window, Center Section of Main House, 2002

The back band molding profile of several windows on the east façade of the center block appears to date to the late nineteenth-century; this profile is identified as “Type 3 – c. 1880” in Figure 7, and it differs quite obviously from the profiles from other periods. One of the windows that bear this molding profile is located in the portion of the north wall of the center section that was covered by the hipped roof appendage depicted in the 1872 photograph. This window is shown in Figure 32. The interrupted

stonework below this window also indicates that the opening was originally larger; it may have served as an interior doorway between the center section and the hipped roof north addition. The 1872 photograph and the late nineteenth century appearance of the molding profile around this window helps to date the removal of the north appendage and the

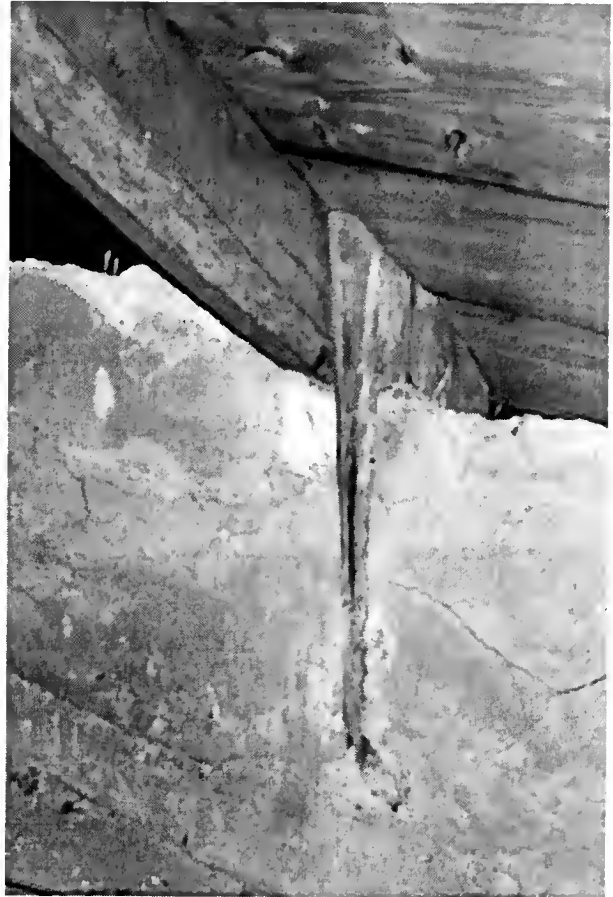
**Figure 33** Remnant of Partition Wall in Attic of the Center Section of the Main House, 2002

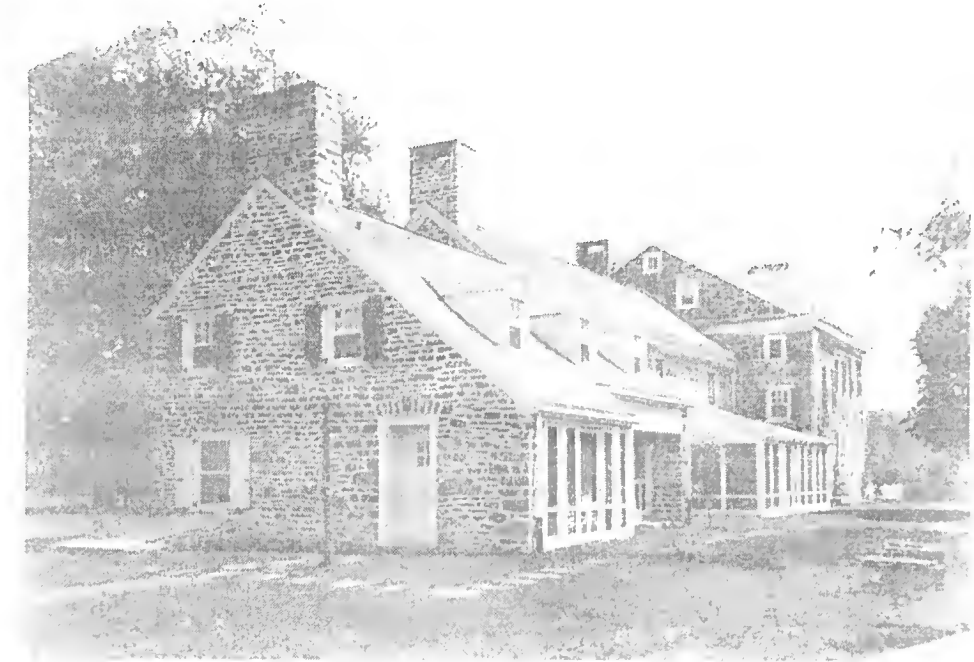
**Figure 34 North and West Facades of Manor House, looking southeast, c. 1930**

The Okie designed 1 1/2-story north wing, seen in Figure 34 in a photograph taken after the entire renovation of the house had been completed, is set back from the front façade of the center block. It is constructed of random-coursed stonework and has a full basement. As seen in the photograph, the new wing has an asymmetrical wood shingled side gable roof that extends as a shed roof on the west façade, a closed cornice of beaded bargeboards and an interior center chimney at its north gable-end.

Built to provide servants quarters and a laundry, this wing has no principle façade. The east facade has three bays at the first level and one small bay above. The south most bay contains a six-panel door with multi-panel reveal at the jambs and flared ionic wood casing. A rough keystone flanked on both sides by two long, thin stones caps the doorway. The north façade is asymmetrical due to the differently pitched rooflines and placement of the fenestration. There are two windows on the second floor and one window and a door on the first floor. The recessed door at the west end of the facade has a raised panel jamb reveal, a flaring ionic-style casing, and a lintel composed of slightly

arched stonework with a central keystone. The first floor window is located at the east end of the façade over the stone framed basement bulkhead. The west (rear) facade reads as a one-story building. Along this facade is an enclosed 10' porch (Okie's drawings

The Okie design also added a large shed roof screened porch to the southern half of the west façade of the center block (visible in Figure 34). The same photograph also depicts a wood shingle roof with pole gutters (a common design feature of Okie’s work) covering the entire house. The dormers on the center section of the house were probably removed during the construction of this new roof. The front porch of the center block was

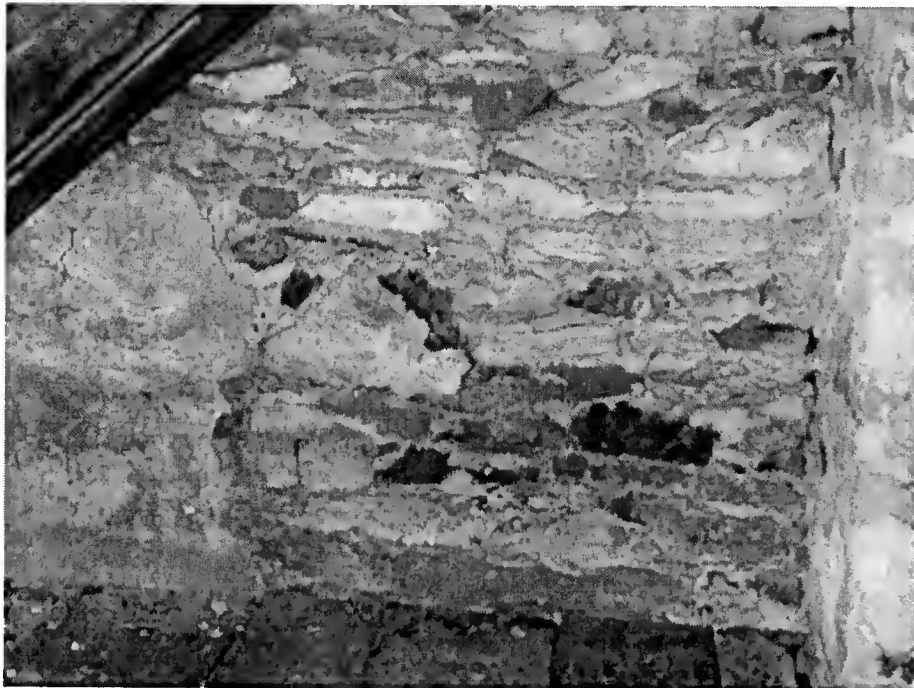
**Figure 35** North Gable-End Wall in Attic of the Center Section of the Main House, 2002

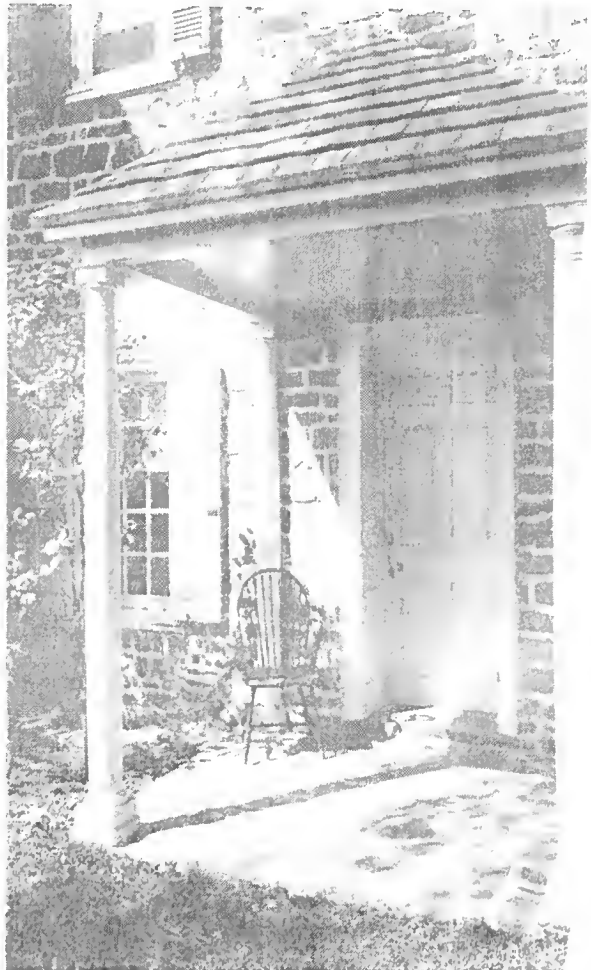
**Figure 37** Post-Okie Porch, East Façade of Center Section of the Main House, c. 1930

also redesigned and rebuilt at this time; see Figure 37. In addition, the exterior masonry appears to have been re-pointed.

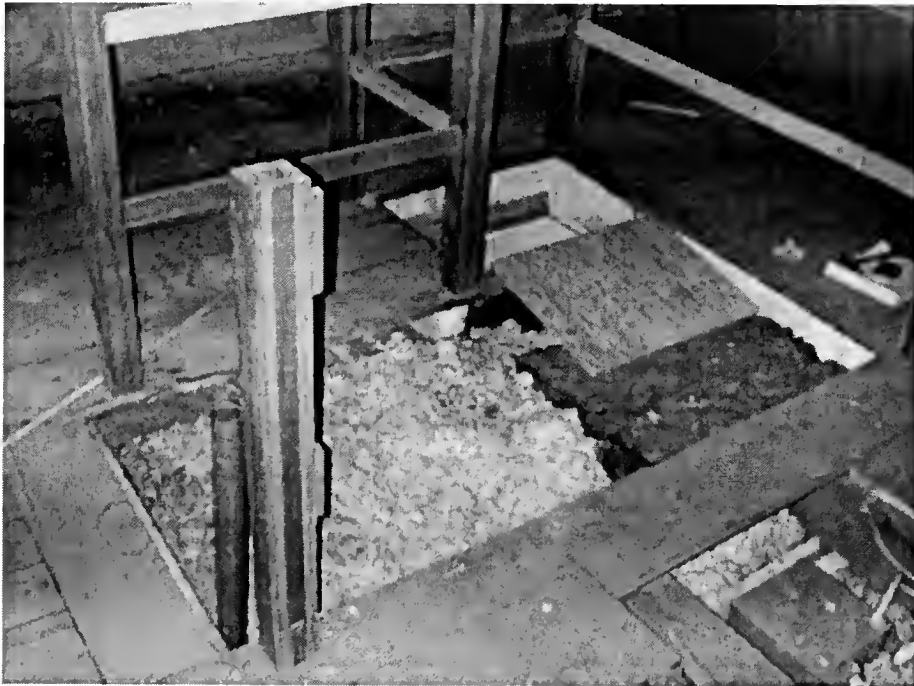
**Figure 39** Third generation Stair Opening in Attic of Center Section of the Main House, 2002

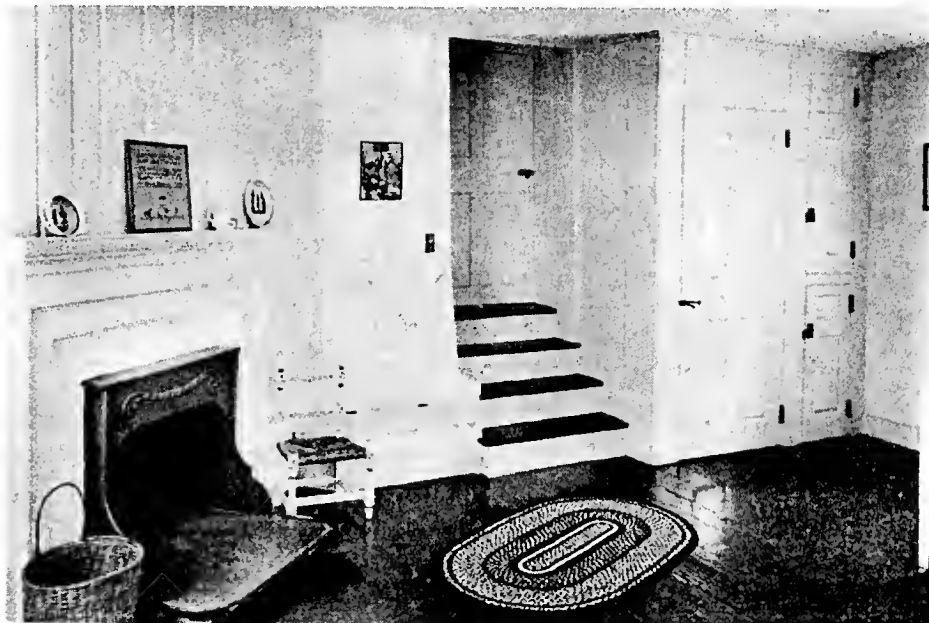
**Figure 40**      **Second Floor South Room, Center Section of Main House, 1925**

Evidence for the physical appearance of the interior of the house after Okie's work, is found in several historic photographs. A photograph of the south room in the first floor of the center block, shown in Figure 40, was published in 1925 with the caption that Richardson Brognard Okie had designed alterations. This photograph depicts a wood floor and a random width, tongue-and-groove wood paneled wall around a corner fireplace with a cast iron Franklin stove insert and decorative wood surround and

mantelpiece. The fireplace insert in the photograph was cast at Warwick Furnace. The rest of the south wall, also depicted in the photograph, consisted of a built-in wood bench with hinged seat, steps leading up to the doorway into the adjoining wing, a large closet with a six-paneled door with wrought iron latch, and, in the corner, several small raised panel cupboard doors with wrought iron hardware. Other photographs, Figure 41 and Figure 42, from the same period, depict the interior of the north wing. The appearance of the mantelpiece, fireplace, and jamb reveals of the windows on the south wall of the first floor east room of the south wing (shown in Figure 22) is representational of interior work done by Okie. The jamb reveals and built-ins around the windows in the other room on first floor, and around the windows in the south wall of the second and third floors also indicate changes made by Okie.

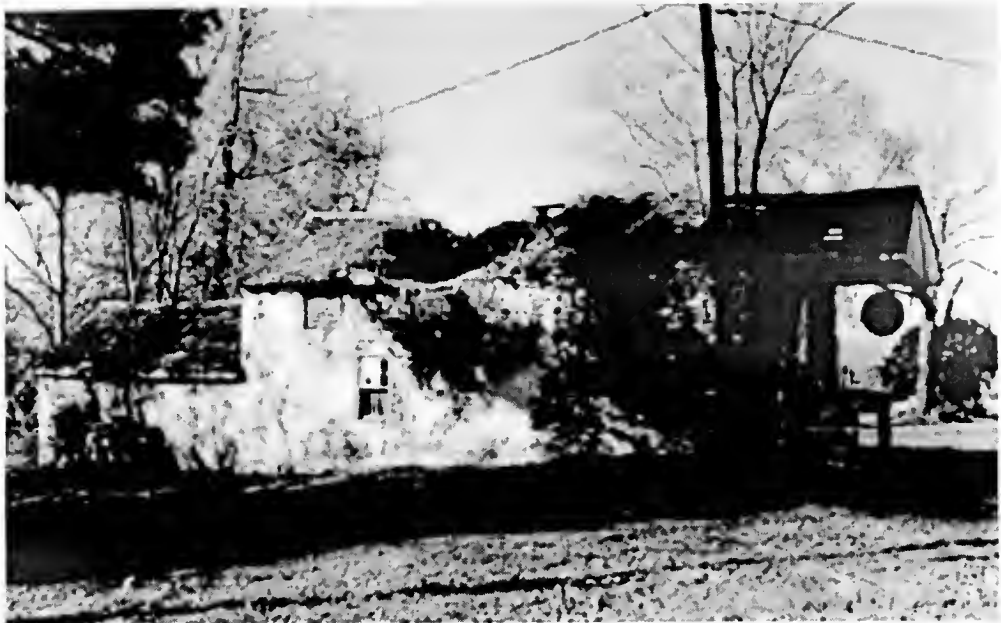
**Figure 44** Smokehouse/Root Cellar, looking north, 2001

maintenance. Both buildings are in poor condition with extensive water damage. The smokehouse/root cellar, especially the eastern section, which is probably the oldest portion of the building, is in particularly poor condition, as seen in the photograph in Figure 44.

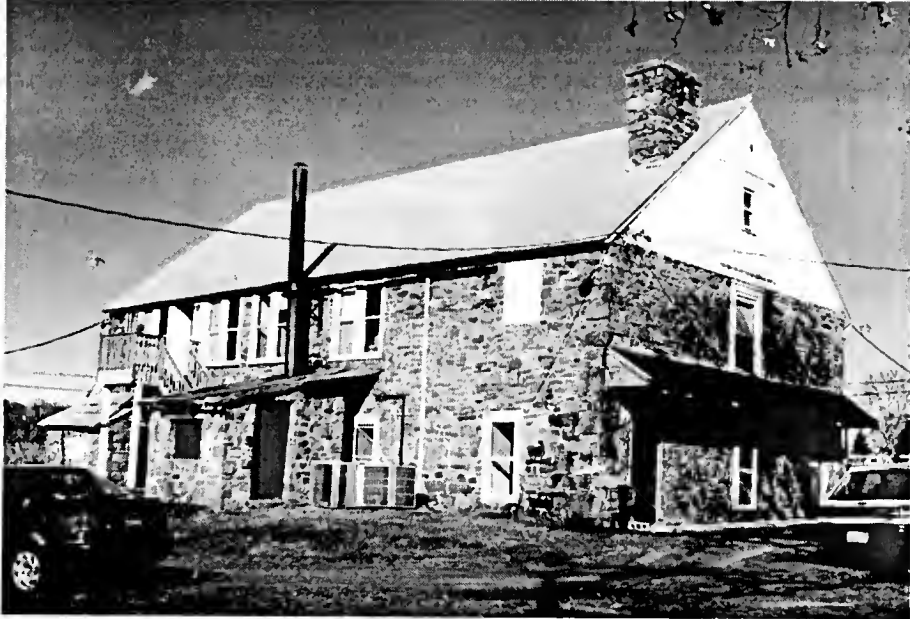
**Figure 45** Barn, looking northeast, 2001

The barn, gristmill/sawmill, and manor house remained in daily use longer than any of the other extant historic buildings. In order for this to occur, these buildings underwent significant alteration. The alterations made to the gristmill are not known since the building was destroyed in a fire in the early 1990s (only the lower portions of the exterior walls remain standing as shown in the photograph in Figure 46). The barn was gutted and renovated in the 1980s to provide classroom space for Pine Forge Academy; its current appearance is depicted in the photograph in Figure 45. Although its interior has been

altered, the building retains integrity of location, size, construction materials, and the form of its original exterior appearance.

North of the main house is a 50’ x 25’, 2-story rubble stone barn (seen in the current photograph in Figure 45). According to payments recorded in the Pine Forge

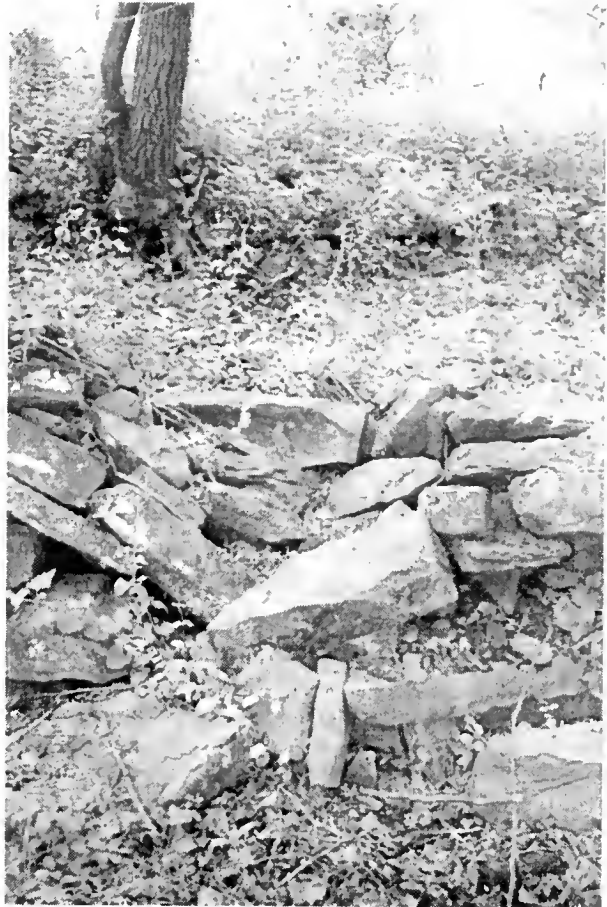
**Figure 47 Stonework of the Dam, 2001**

that it was essentially a soil berm with stone reinforcement. Figure 47 shows the large rectangular blocks of stone, laid in a regular pattern, that identify the extent of the current dam structure. The upstream (north) side of the dam appears to have been earth while the downstream (south) side was reinforced with stone. This stone has a color and appearance similar to that used in the construction of the south wing of the main house. The millrace was similarly constructed.
